Removable Beryllium Contamination Found on Radiation Monitoring Instruments

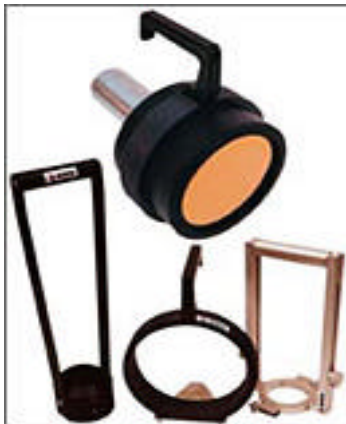
The standard instrument utilizes a thin sodium iodide crystal, quartz light pipe, photomultiplier tube, and beryllium radiation entrance window hermetically sealed within aluminum housing.

The preliminary results of the beryllium swipes showed elevated levels of surface contamination. The source of the beryllium contamination was believed to be oxidation of unprotected beryllium windows on the old probes.

- Sites should identify if they have similar sources of beryllium contamination (for example, do they have sodium iodide scintillation detector probes with beryllium windows in use or in storage). Specifically, sites should determine if they have beryllium articles that, through mechanical (e.g., physical abrasion) or chemical (e.g., oxidation over extended time periods) processes, could be a source of beryllium contamination.

- Sites should consider controlling worker exposure to any sources of beryllium contamination that they find.
- Sites should consider replacing beryllium articles that are a source of beryllium contamination with alternate, non-beryllium containing materials.
